## **Roof Inspection Report**

### **Bicentennial Elementary School**

**296 East Dunstable Road  
Nashua, NH 03062**

Prepared By: ARM Consultants LLC

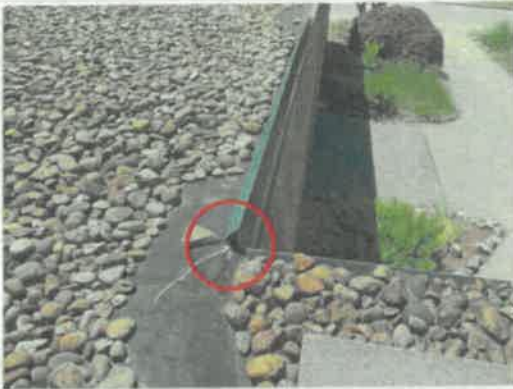
| Observation | Description |
|---|---|
| | 1. Open corner metal perimeter flashing. Provide EPDM patch. |

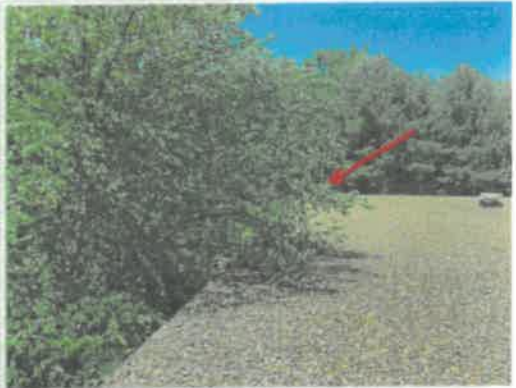
| Observation | Description |
|---|---|
| | 2. Tree overhanging roof. These limbs should be trimmed back so that they are not in contact with the roof. |

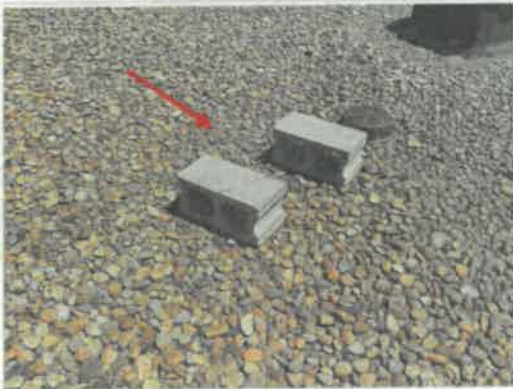
| Observation | Description |
|---|---|
| | 3. Construction materials and miscellaneous debris were noted in several roof areas. Debris should be removed during annual roof maintenance inspections. |

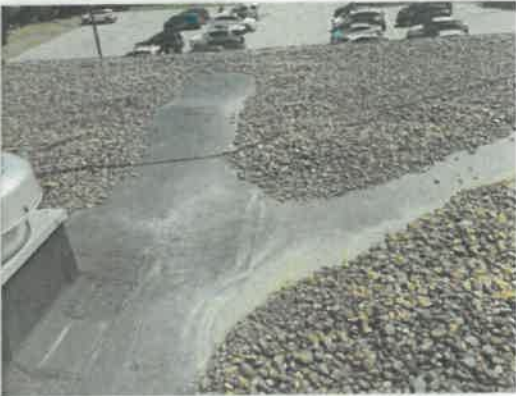
| Observation | Description |
|---|---|
| | 4. Roof ballast should be redistributed in the areas where the roof membrane is exposed. |

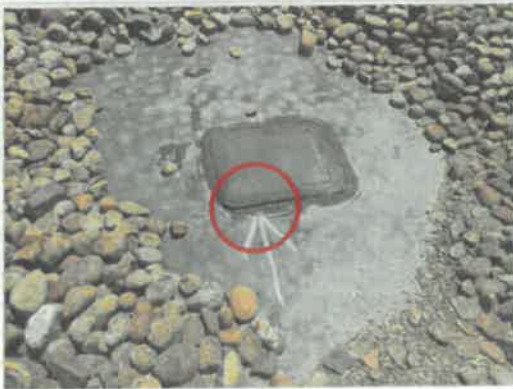
| Observation | Description |
|---|---|
| | 5. Peeling edge of patch. Provide new EPDM patch in accordance with Carlisle guidelines. |

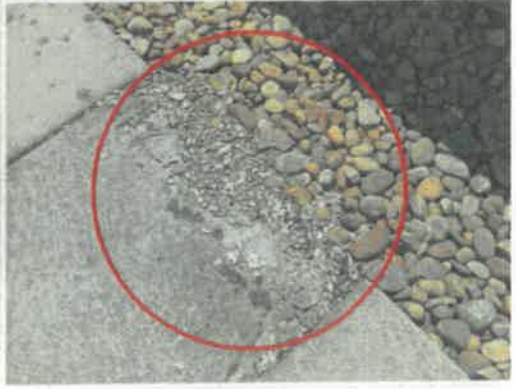
| Observation | Description |
|---|---|
| | 6. Deteriorating pavers should be replaced with new roof top pavers to protect the existing roof membrane from damage. |

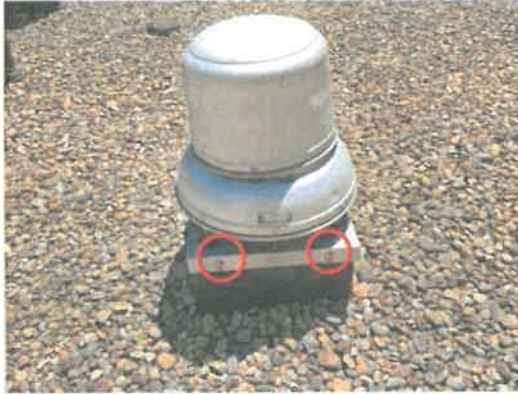
7. The majority of the roof top fans were noted to have missing or non-grommited fasteners. Grommited fasteners should be provided at each attachment point. Existing non-grommited fasteners should be caulked.

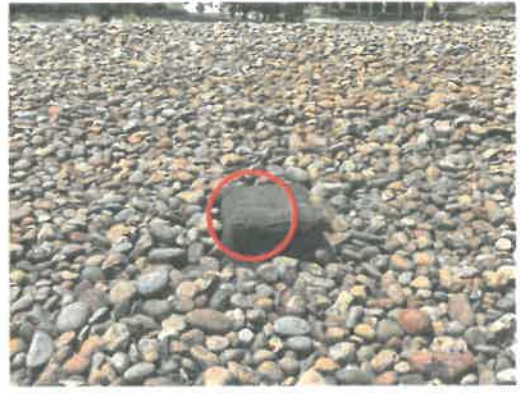
8. Multiple holes in found in flashing of obsolete penetration. Provide new EPDM flashing in accordance with Carlisle guidelines.

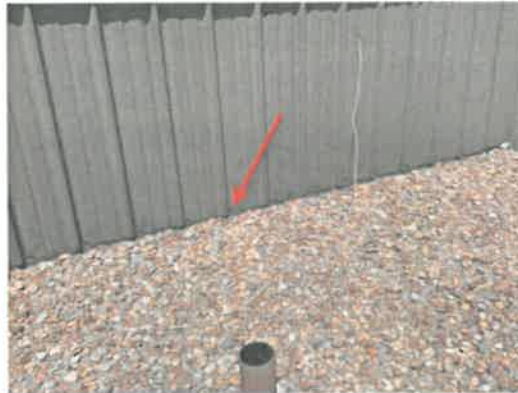
9. Low flashing height was noted in several areas. These areas should be monitored to ensure that these areas do not become prone to leaking. If no problems appear, these flashing heights should be addressed during new construction.

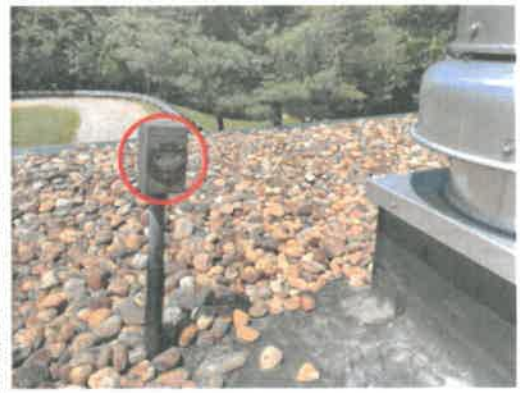
10. Open electrical boxes should be sealed per local code. An alternative would be to remove the electrical boxes and conduit and the roof should be repaired in accordance with Carlisle guidelines.

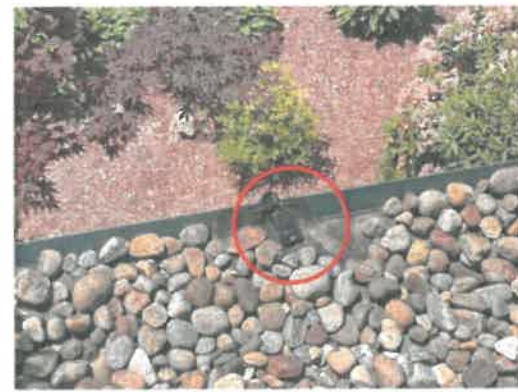
11. Open flashing noted at the perimeter edge. Provide new EPDM patch in accordance with Carlisle guidelines.

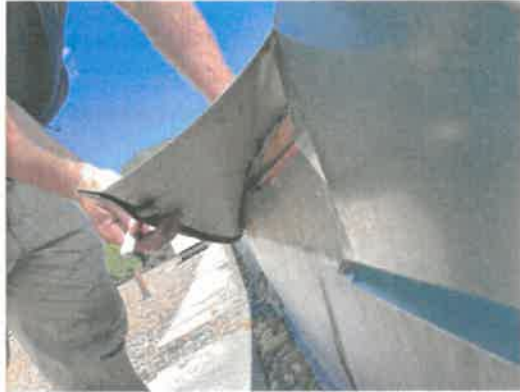
12. Metal edge fascia with no hook strip or dutch clips. This fascia should be secured to the plywood with minimum No. 8 grommited screws at 16 inches on center. These fasteners should be installed along the lower 1/3 of the flashing.

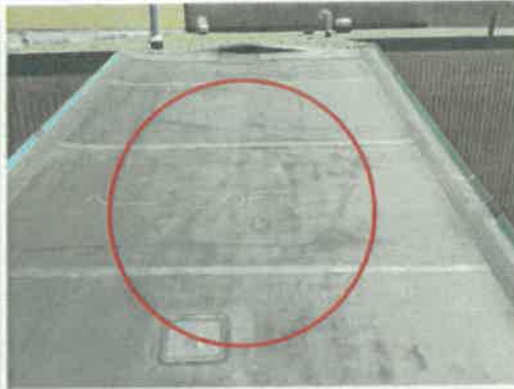
13. Soft insulation below roof membrane. These areas should be monitored to ensure that the area of soft insulation does not expand. It may be advisable to have an infrared scan completed to determine if the roof insulation in these areas is wet.

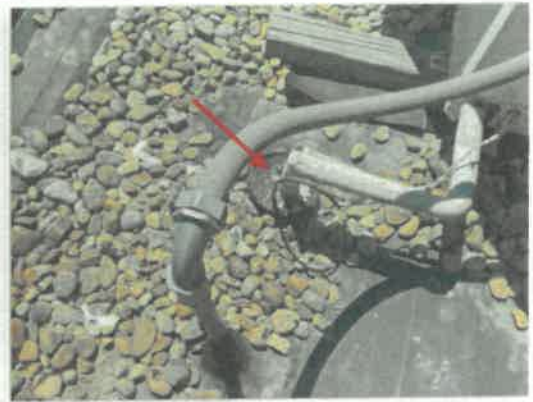
14. Deteriorating pitch pocket. Pitch pocket should be filled with an appropriate pourable sealant.

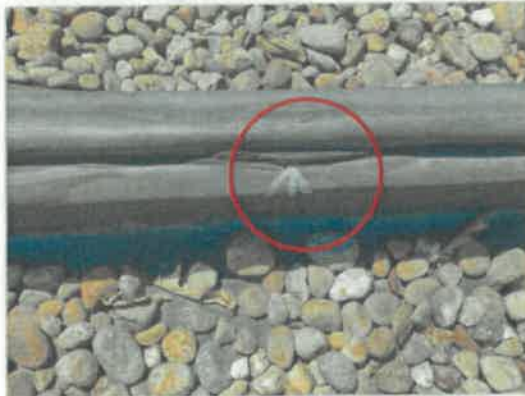
15. Open membrane seam on expansion joint. Provide EPDM patch in accordance with manufacturers guidelines.

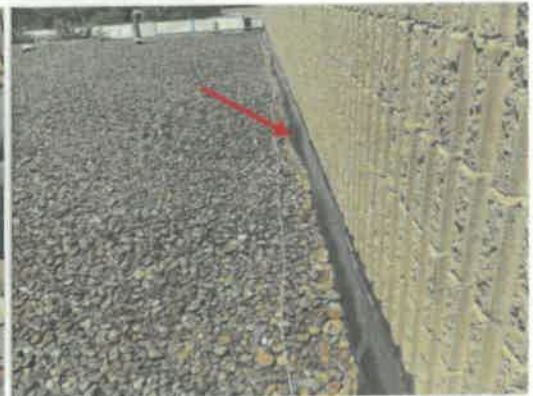
16. Membrane bridging was noted along several rising interior walls. This occurs due to membrane shrinkage and the lack of adequate termination of the membrane. The membrane should be cut, allowed to relax and stripped in.

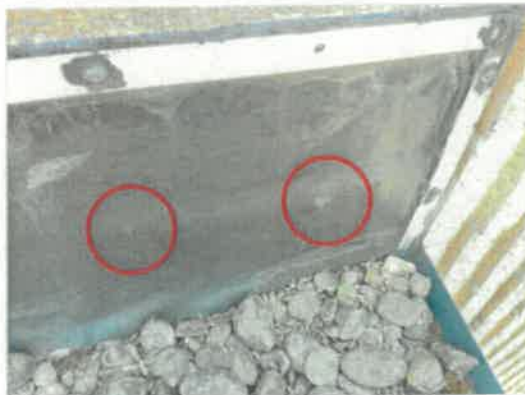
17. Tented fasteners were identified in several areas of the facility. Provide EPDM patches over these fasteners in accordance with Carlisle guidelines.

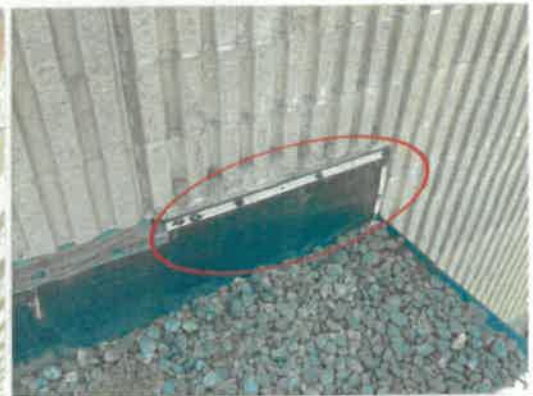
18. Missing through wall flashing cover. Provide caulking over this entire termination bar to provide a water tight condition.

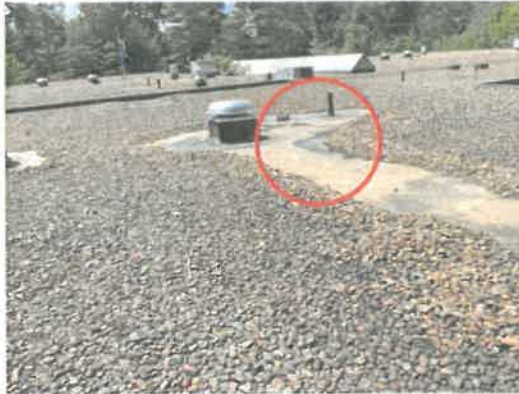
19. Evidence of roof ponding was identified in several roof areas. These areas should be monitored to ensure that the ponding does not worsen to the point that the roof insulation is damaged.

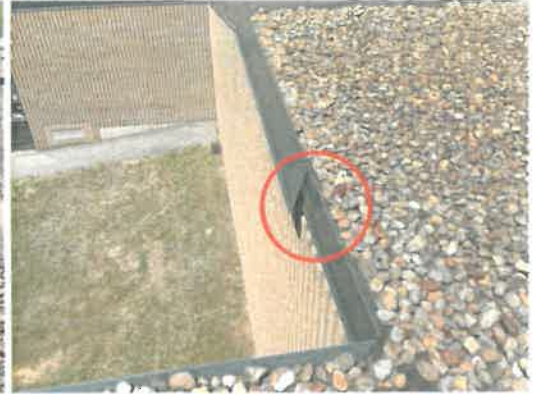
20. Loose edge metal flashing. This edge metal should be resecured.

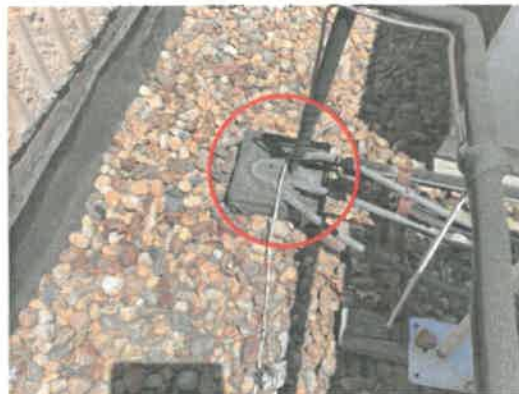
21. Pitch pocket with multiple cables. The pourable sealant has deteriorated, and Karnak has been applied. These materials are not compatible, and the pitch pocket should be reworked with an appropriate pourable sealant.

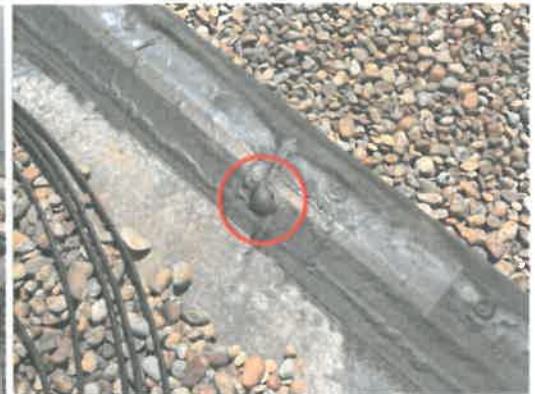
22. Blister on EPDM stripping at roof perimeter. Provide new EPDM patch in accordance with Carlisle guidelines.

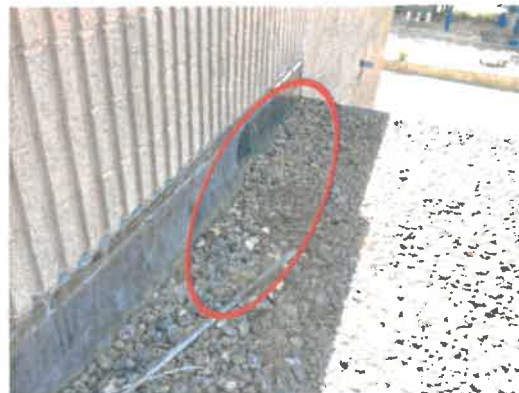
23. Organic growth should be removed during annual roof maintenance.

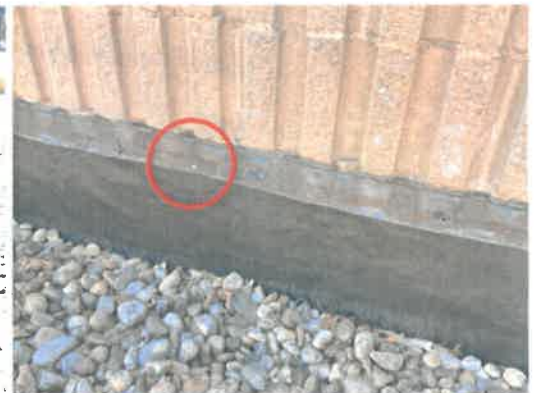
24. Uncaulked rivets were noted at the base of several rising walls. Provide caulking of these rivet in accordance with Carlisle guidelines.

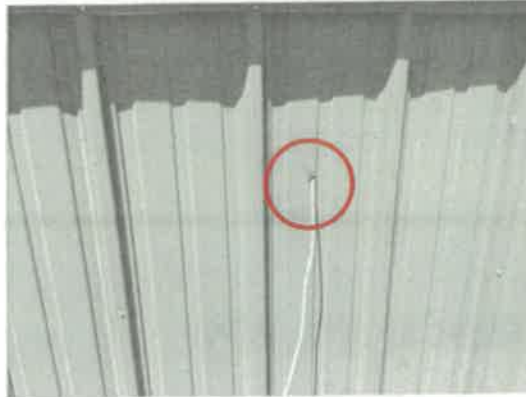
25. Improperly sealed wall penetration. Provide penetration seal in accordance with the metal building manufacturers guidelines.

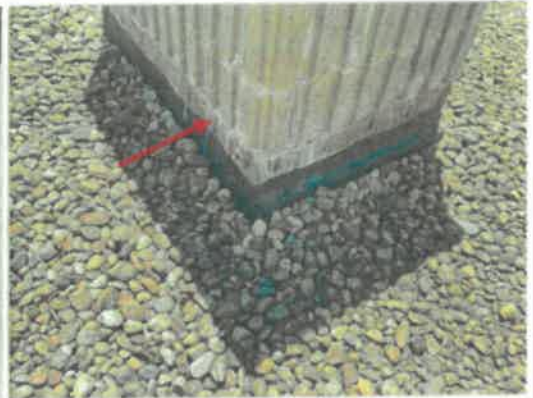
26. Chimney flashing has been re-bent multiple times. Replacement of this flashing should be considered during future roof construction.
