# AD HOC JOINT COMMITTEE ON CAPITAL EXPENDITURES AND DEBT SERVICE PLANNING

# Nashua School District Capital Improvements

## **Roof Inspection Report**

### **Bicentennial Elementary School**

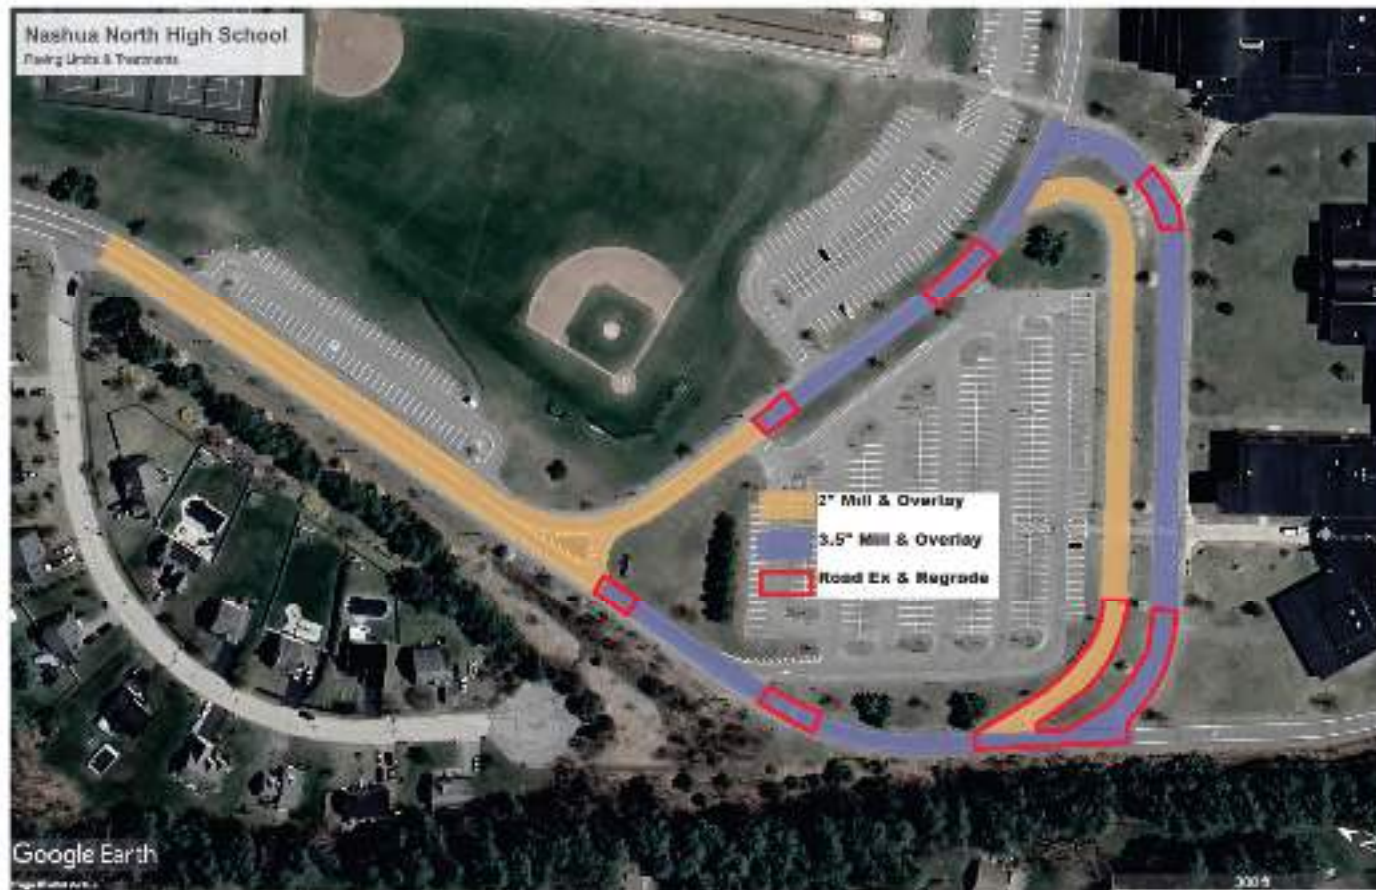
# NHS North Paving Summer 2025

- With about \$1million allocated the past two fiscal years, the following projects were completed this past summer/fall:
  - Resurface North HS Track
  - Paving work at NHS North – Worked with DPW to include this with their city paving work this past summer. Titan Way and the two drop off loops were completed.
  - Roofing repairs at various schools – Conducted roofing repairs to extend service life at 6 elementary schools and the two high schools.
  - Replacing PA & Bell Systems at the two high schools.
  - Resurfacing NHS South & NHS North Tennis Courts.

- As noted previously, we paved the entry road, parent and bus drop off loops, and a portion of the departure lane, this past summer.
- If funding remains at same level, a project is in the FY27 Deferred Maintenance plan to address the next section of pavement. This piecemeal approach will probably take 3-4 years to completely restore the pavement.
- We are, however, proposing to completely pave the remaining portions of the site with this capital project. Estimate cost to complete this project is \$1,400,000.

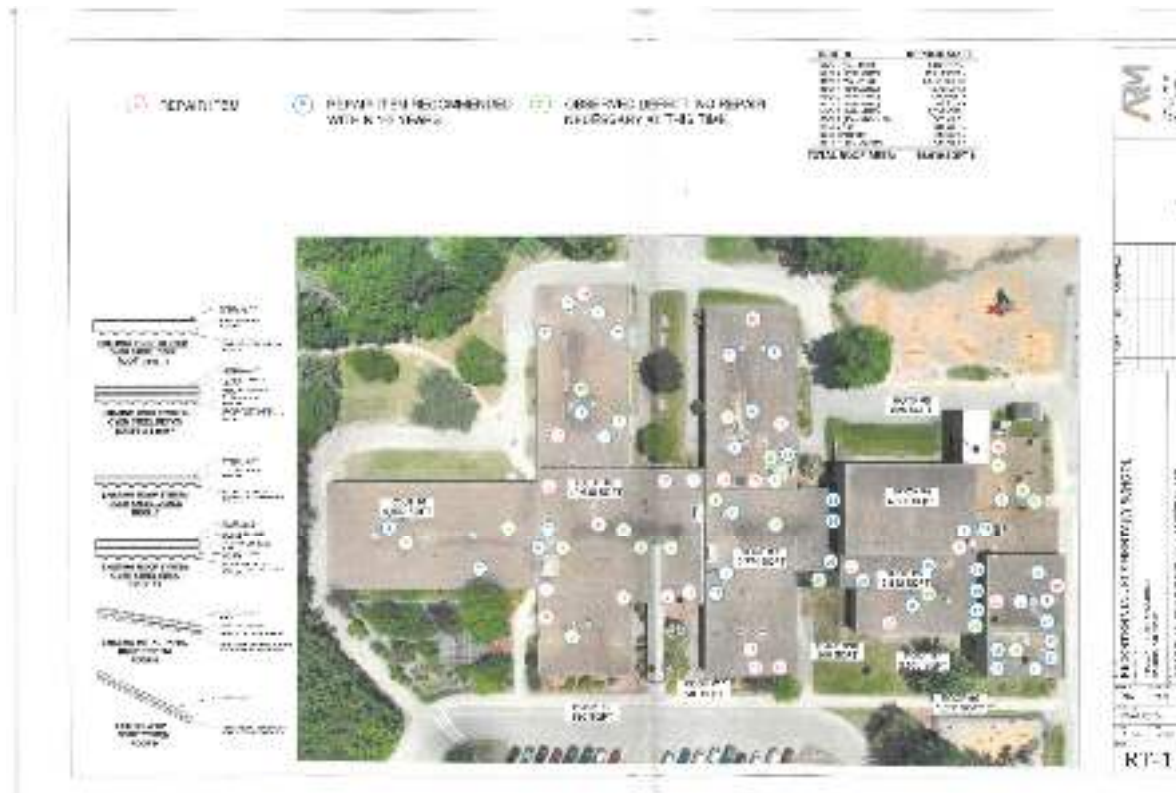
# Bicentennial Elementary Roof Replacement

- A roofing assessment was conducted by ARM Consulting summer of 2024 summer. This assessment found a significant number of immediate issues, which the school district addressed.
- The repairs will lengthen the service life of the roofing 2-3 years (or to 2026/27).
- If approved, we will bid out the roof replacement next winter, for a summer 2027 installation. Estimated cost is \$1,857,090.

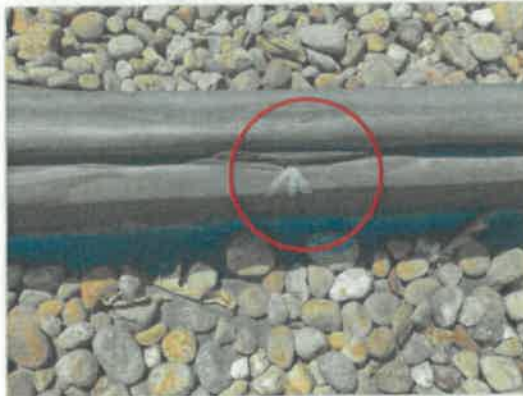
15. Open membrane seam on expansion joint. Provide EPDM patch in accordance with manufacturers guidelines.

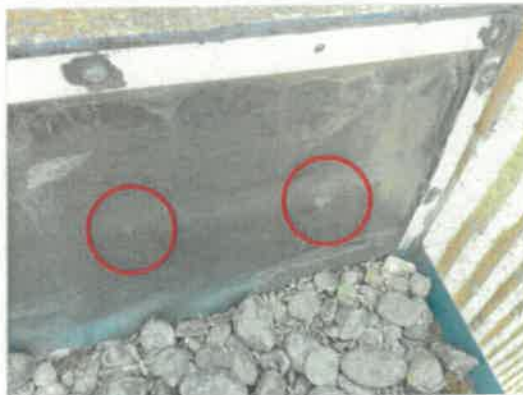
17. Tented fasteners were identified in several areas of the facility. Provide EPDM patches over these fasteners in accordance with Carlisle guidelines.
